DEPARTMENT OF TRANSPORTATION**DIVISION OF ENGINEERING SERVICES**

Contract #: 04-0120F4Cty: SF/ALA Rte: 80 PM: 13.2/13.9File #: 69.28**WELDING INSPECTION REPORT****Resident Engineer:**Siegenthaler, Peter**Address:** 333 Burma Road**City:** Oakland, CA 94607**Report No:** WIR-019749**Date Inspected:** 14-Dec-2010**Project Name:** SAS Superstructure**OSM Arrival Time:** 700**Prime Contractor:** American Bridge/Fluor Enterprises, a JV**OSM Departure Time:** 1900**Contractor:** Zhenhua Port Machinery Company, Ltd (ZPMC), Changxing Island **Location:** Shanghai, China**CWI Name:** Qiu Wen**CWI Present:** Yes No**Inspected CWI report:** Yes No N/A**Rod Oven in Use:** Yes No N/A**Electrode to specification:** Yes No N/A**Weld Procedures Followed:** Yes No N/A**Qualified Welders:** Yes No N/A**Verified Joint Fit-up:** Yes No N/A**Approved Drawings:** Yes No N/A**Approved WPS:** Yes No N/A**Delayed / Cancelled:** Yes No N/A**Bridge No:** 34-0006**Component:** OBG**Summary of Items Observed:**

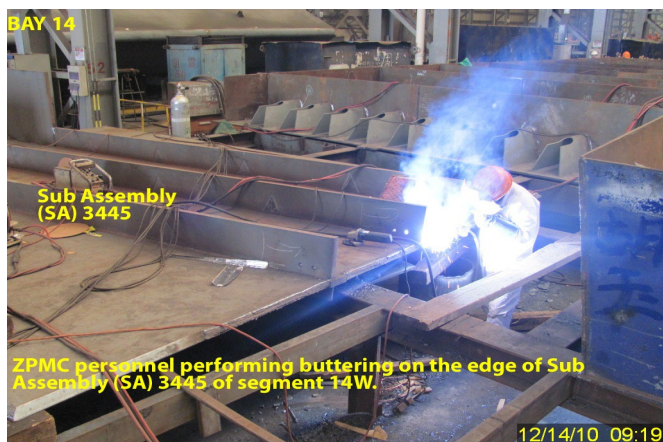
During random in process inspection this QA inspector observed ZPMC personnel were performing buttering of approx 35mm by FCAW (ESAB) process on the edge of Sub Assembly (SA) 3445 of segment 14W. Buttering was done as per Welding Repair Report B-WR18331. The material is identified as SPCM. This issue has been discussed with ZPMC CWI Mr. Qiu Wen and CT lead QA. ZPMC CWI Mr. Qiu Wen informed this QA that they will do the repair as comply to contract documents. Attached photograph provide additional details.
